FINAL

PHASE I ENVIRONMENTAL BASELINE SURVEY NELLIS TERRACE HOUSING AREA, PARCEL E-1 NELLIS AIR FORCE BASE, NEVADA

MARCH 2010

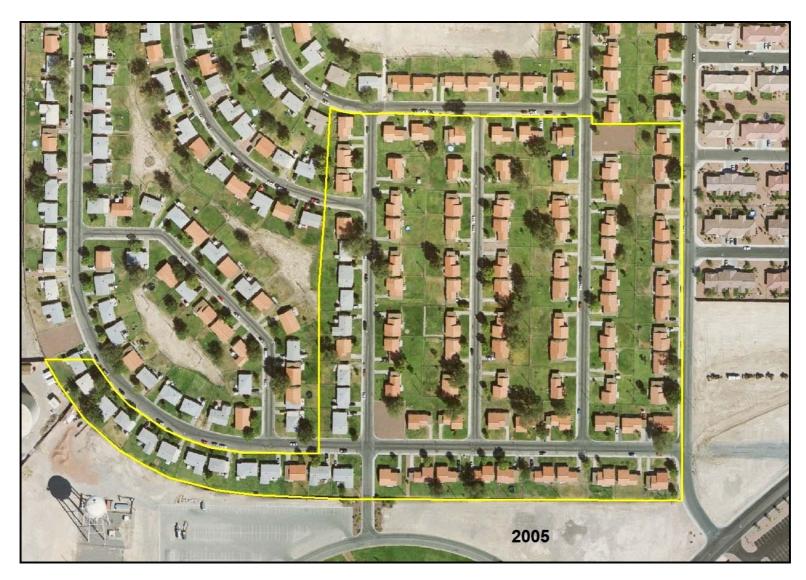
Figure 2. 2005 aerial photo of Parcel E-1.

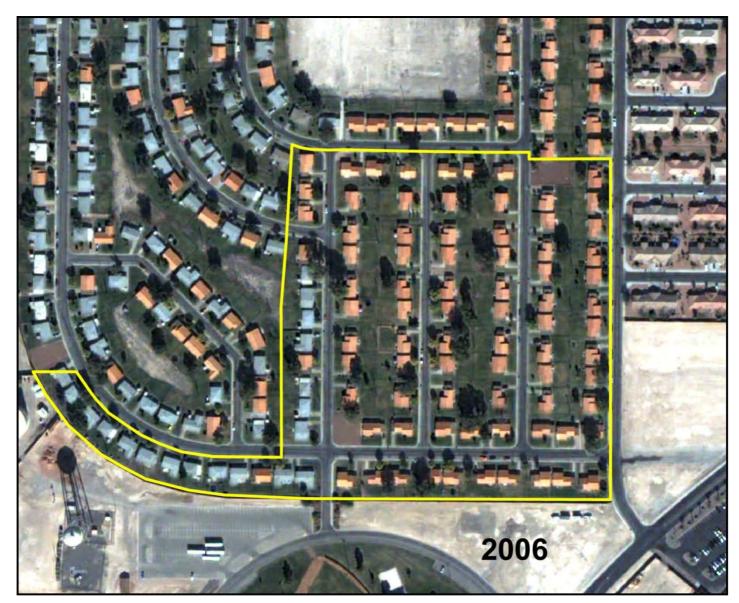
Figure 3. 2006 aerial photo of Parcel E-1.

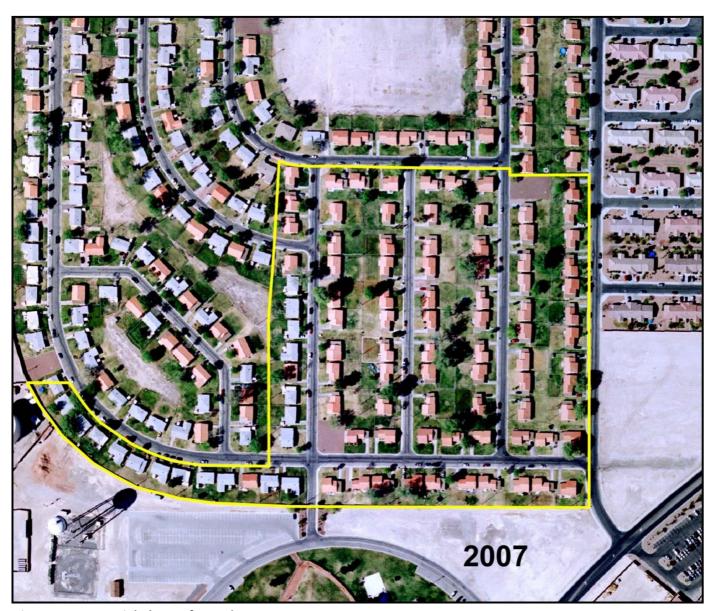
Figure 4. 2007 aerial photo of Parcel E-1.

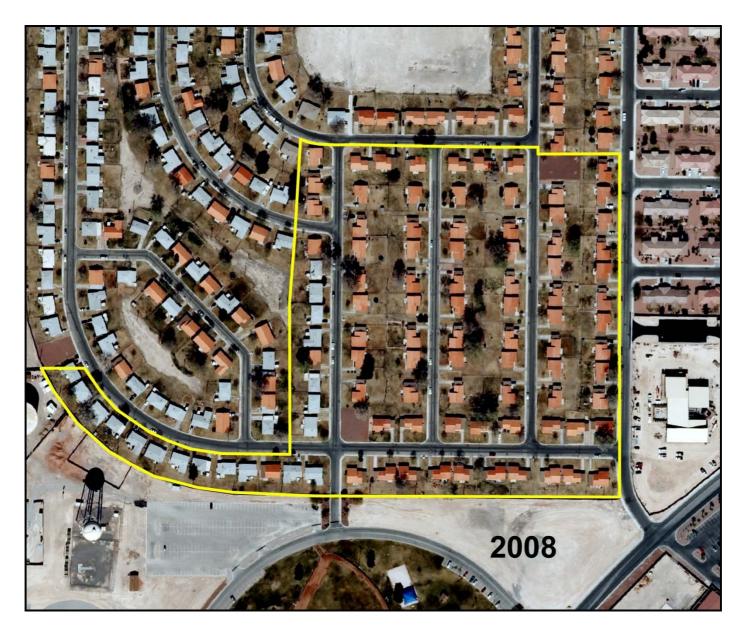
Figure 5. 2008 aerial photo of parcel E-1.

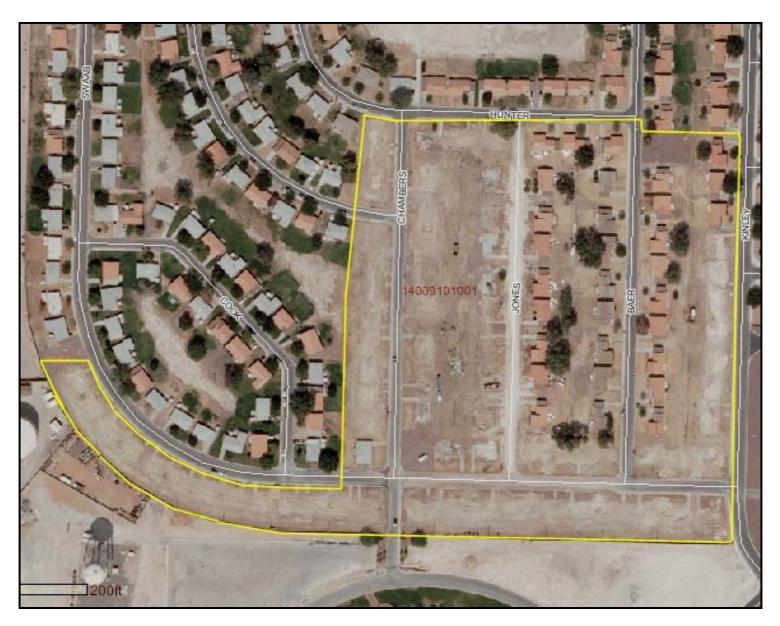
Figure 6. Aerial photo of Parcel E-1 taken in 2009 during housing demolition.
